PROJECT NO.  
**4650A**

# **An Evaluation of the Value of Structurally Enhanced PVC Pipe**

**David M. Hughes**  
American Water

**2018**

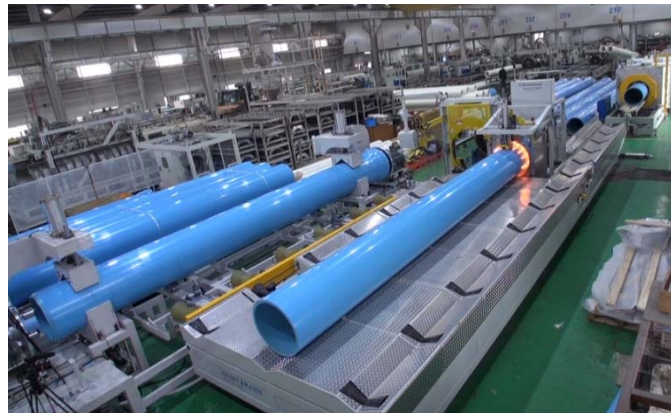
**Figure 2.7 PVC extrusion line**

The manufacturing process of PVC pipe involves either extrusion process or injection molding. During injection, molding process the molten polymerized polymer is forced in to the pipe molds and then water-cooled. During the extrusion process (Figure 2.7), the molten polymerized polymer is extruded using single/multi screw extruders and water cooled to obtain the PVC pipe. No coatings or linings are added.

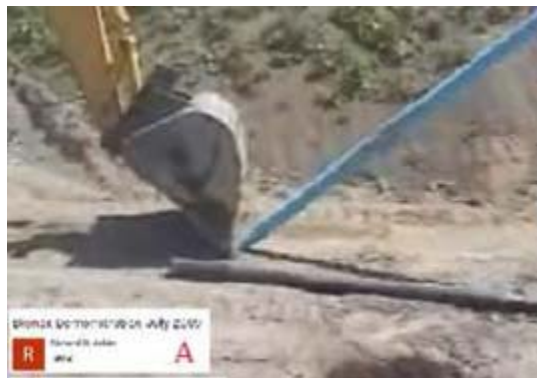
**Figure 2.8 IPEX field test of its C909 under pressure from YouTube**

Both PPII and manufacturers of PVC-O have videoed visually impressive field demonstrations to show pipe strength of extruded PVC pipe. While ductile iron material exhibits superior structural strength, Demonstrations such as those pictured in Figure 2.8 show field impact tests that a ductile iron pipe cannot execute without heavy damage.

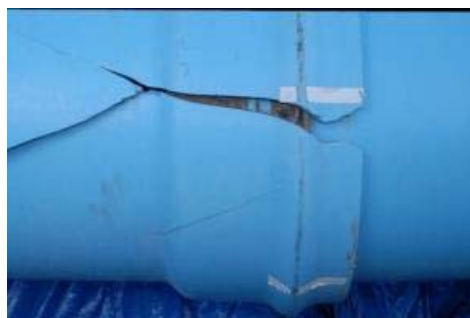
**Figure 2.10 Bell split of PVC pipe**

**Failure Due to Poor Installation.** The pipe undergoes premature failure when not installed per manufacturer direction, specifications, and standards (Gramann et al, 2009). PVC pipe should be handled carefully to prevent any breakage or minor damage that can grow worse with time. Installers can over-insert the spigot of the pipe into the bell as shown in Figure 2.10. The pipe typically has clear markings to insert the pipe the correct way. Gasket issues such as over or under lubrication and trapped debris are universal to bell and spigot pipes. Improper bedding preparation that fails to provide uniform support for the pipe is a significant problem found with PVC. Placing the pipe on sharp protruding materials stresses the pipe and can contribute to failure. Because unsupported but loaded PVC pipe tends to lose shape, proper backfill practice (including good material and proper tamping) is vital for conventional PVC pipe installation. The study of non-uniform bedding on PVC pipe conducted by Balkaya et al (2013), demonstrated that the PVC pipe experiences additional stresses in locations of non-uniform support than those with uniform bedding support.

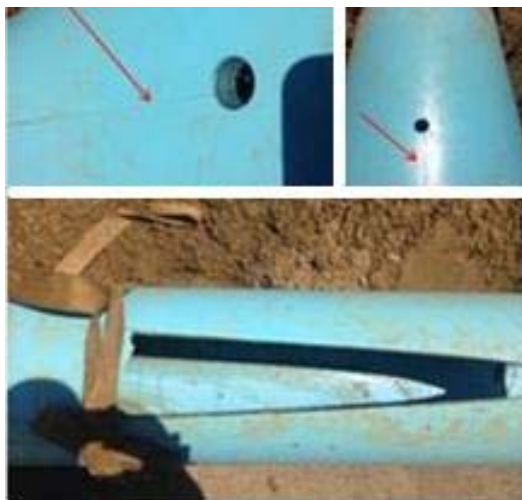
**Figure 2.11 Failure due from tapping**

**Tapping.** A common problem found with early PVC pipe installations was making connections (taps) on the pipe. The AWWA M23, manual recommends the use of saddles for any size and class of pipe. There are instances of PVC pipe failure while performing tapping with saddles. This may be due to the stress induced into the pipe while tapping, the insufficient distance between service connection taps, the use of the wrong tap machine, drill bit or saddle. Over time and with experience, utilities have minimized PVC tapping issues. Figure 2.11 demonstrates recent PVC pipe failure due to tapping using inappropriate tapping tool by the contractor at the American Water in New Jersey.

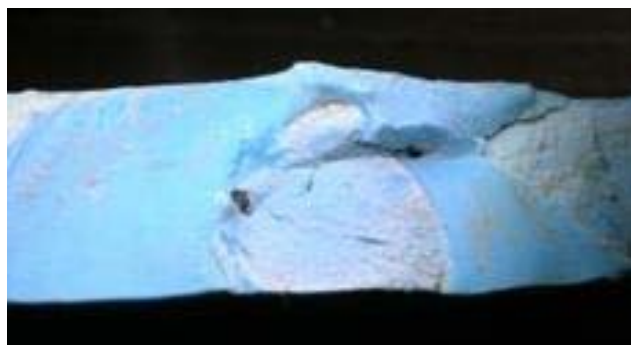
**Figure 2.12 Damage from impurities in pipe**

**Manufacturing.** The defects due to manufacturing have occurred with major impact on the PVC water pipe industry. A well-publicized, contentious but successful lawsuit (subject to appeal) filed against one manufacturer alleging substandard manufacturing may have serious implications. An array of tests can be employed to help confirm material quality when called into question, many of which are identified in subsequent pages. Figure 2.12 is an example of a manufacturing defect when foreign matter is trapped in the plastic during the pipe manufacturing.

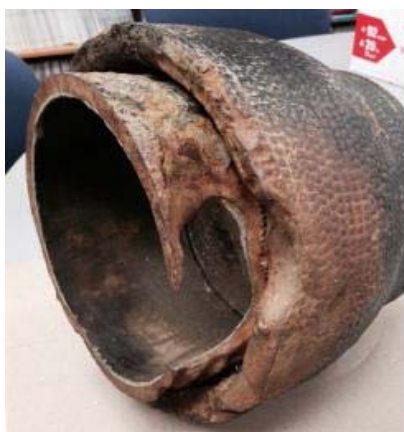
**Figure 2.16 DI corrosion**

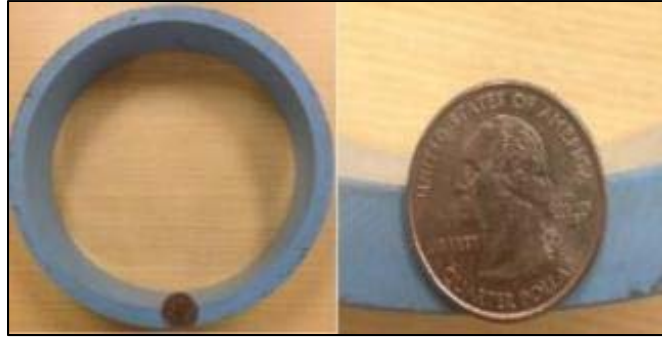
**Figure 2.17 8” DR-18 iPVC wall thickness**

The product studied for this research project is the innovative iPVC pipe. The manufacturer of iPVC pipe, PPII conducted several tests on iPVC pipe well before the research work in the US began. The iPVC pipe has the same thickness as standard PVC (see Figure 2.17).

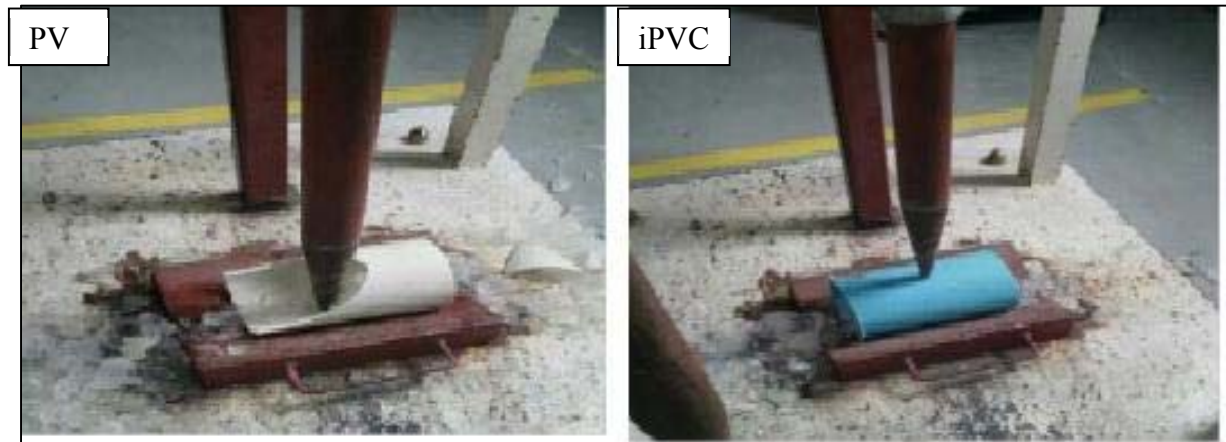
**Figure 2.18 Impact testing on PVC pipe on the left and iPVC on the right**

a height of 16.4 ft. Figure 2.18 displays the contrasting results of the impact of the dropped load on a common PVC pipe and the iPVC.

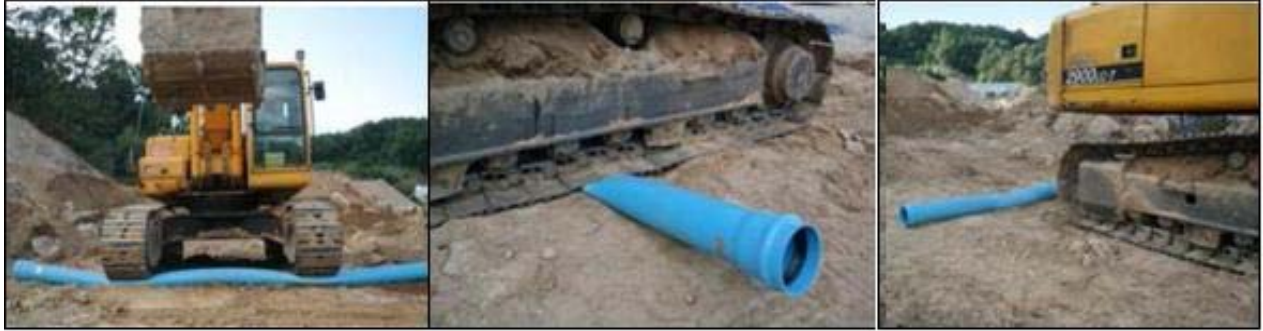
**Figure 2.20 Crawl demonstration**

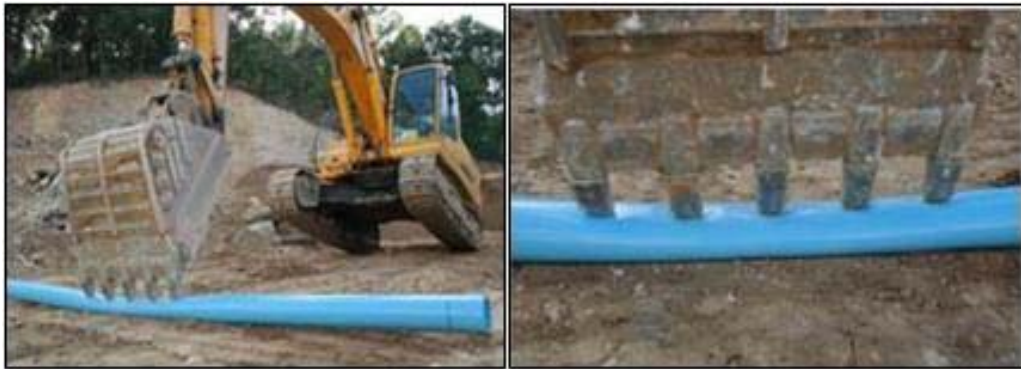
**Figure 2.21 Bucket demonstration**

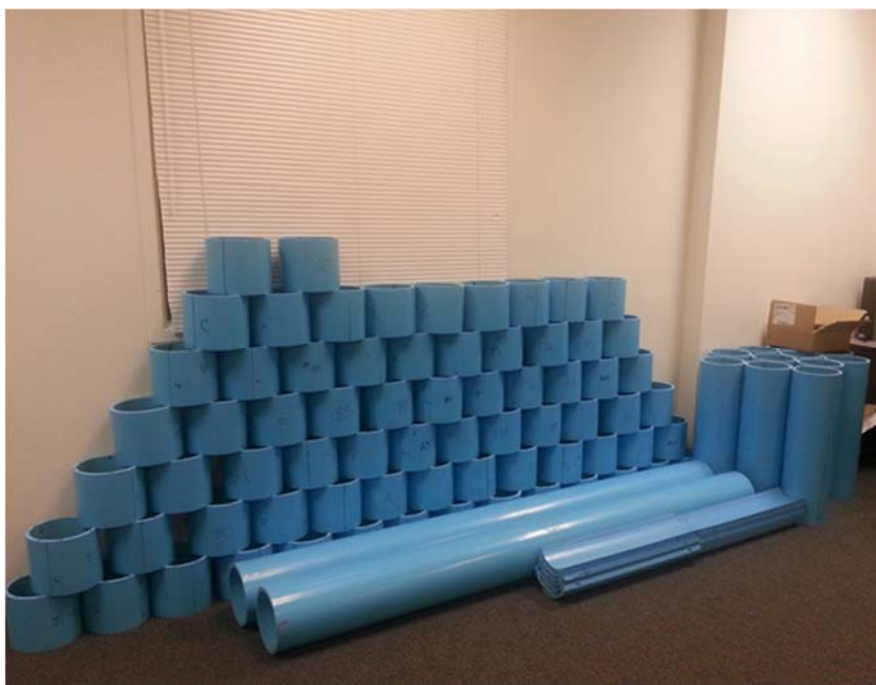
**Figure 3.1 Stockpiled sample material to UTA**

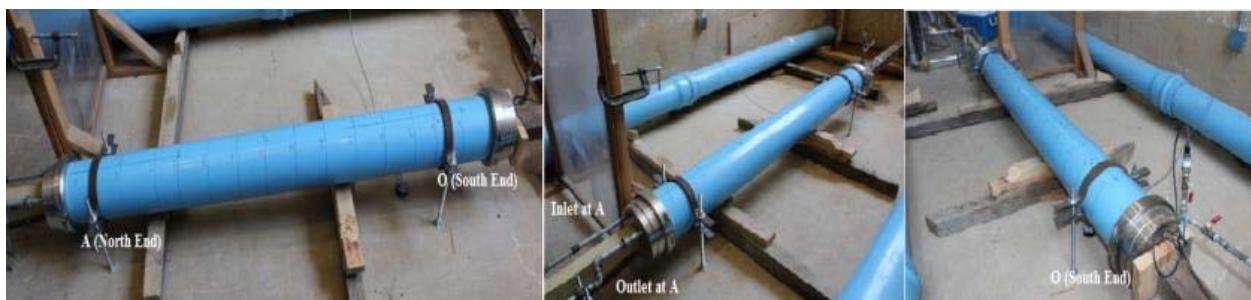
**Figure 3.12 UTA CUIRE fatigue testing set up**

Data is conveyed through a pressure transducer used in the test setup to convert water pressure in the pipe into an analog electrical signal. The transducer is connected to the oscilloscope, which converts the output signal of pressure transducer to a waveform pattern in terms of voltage. The oscilloscope receives a signal from the pressure transducer and demonstrates the pressure waves on a desktop monitor screen. Figure 3.11 and Figure 3.12 present the schematic diagram and the actual fatigue test setup at UTA.

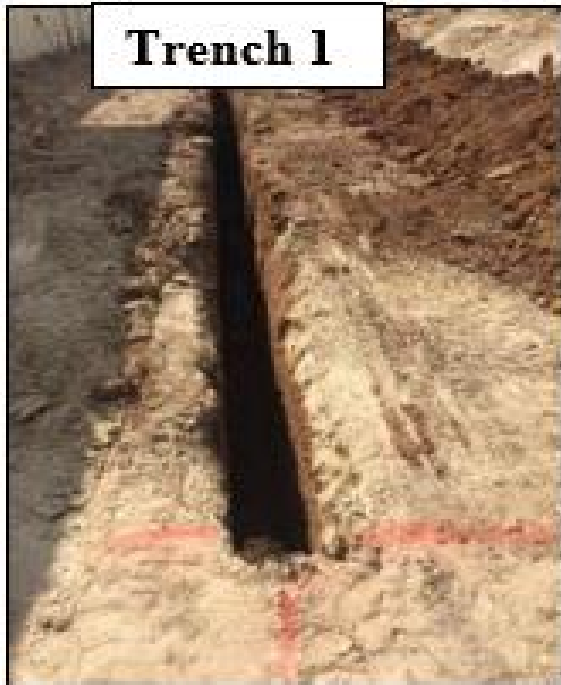
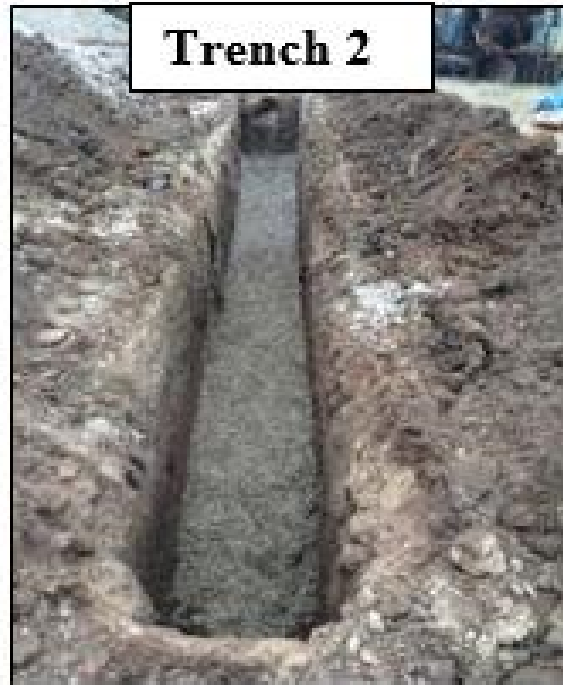
**Figure 3.15 Trench 1 and Trench 2**

Two test pits were excavated for the bedding test. The trenches were 30 feet long, 32 inches wide and 5 feet deep in natural soil. Figure 3.15 presents the test pit for the two tests. Figure 3.16 illustrates the installation details for a second bedding test with additional monitors installed. To understand the characteristics of native soil used as backfilling material, UTA analyzed the soil. The native soil was characterized as silty soil with mixture of sand and clay. Table 3.5 summarizes the native soil investigation at the bedding test locations.

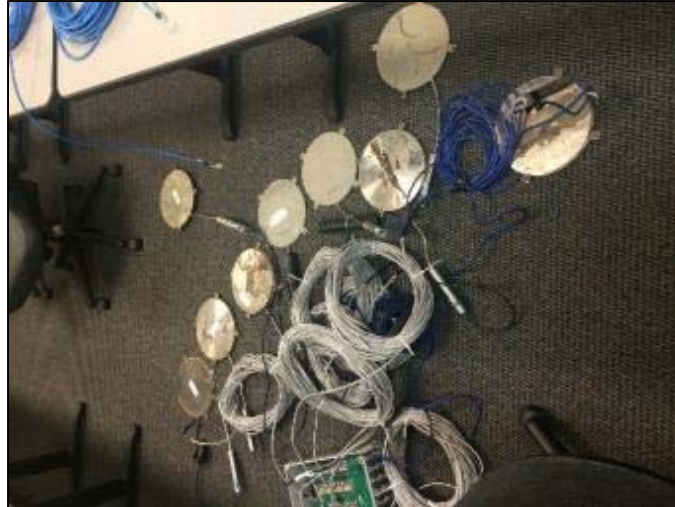
**Figure 3.17 Earth pressure cells used in test**

Geokon™ Model 4810 vibrating wire earth pressure cells illustrated in Figure 3.17 were used for measurement of horizontal and vertical earth pressures in the second test. These sensors consist of two stainless steel plates welded together around their periphery with a narrow gap in between filled with hydraulic fluid. The external pressures experienced by the two plates squeezes them together creating equal pressure in the internal fluid. A length of stainless steel tubing connects the fluid filled cavity to a pressure transducer that converts the fluid pressure into an electrical signal transmitted by a cable to the data logger. The range of the pressure cells used was 51 psi with an accuracy of 0.1%. The details and specifications for the sensor are presented in Appendix B.

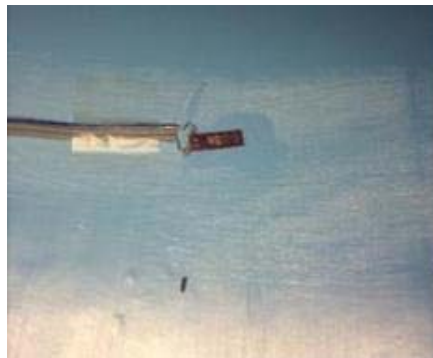
**Figure 3.19 Strain gauge attached to iPVC pipe**

The strain gauges were deployed in the second test to measure the strain on the pipes due to external loads. The experiment uses the gauges manufactured by Tokyo Sokki Kenkyujo Co., Ltd. (Model FLA-6-11) uniaxial strain gauges for the measurement of strains. The installed strain gauge on the pipe is illustrated in Figure 3.19. The details and specifications for the sensor are presented in Appendix B. Installation of strain gauges is a very delicate process. In addition, it is imperative that the surface is properly prepared to secure the gauge. The following steps summarize the installation procedure:

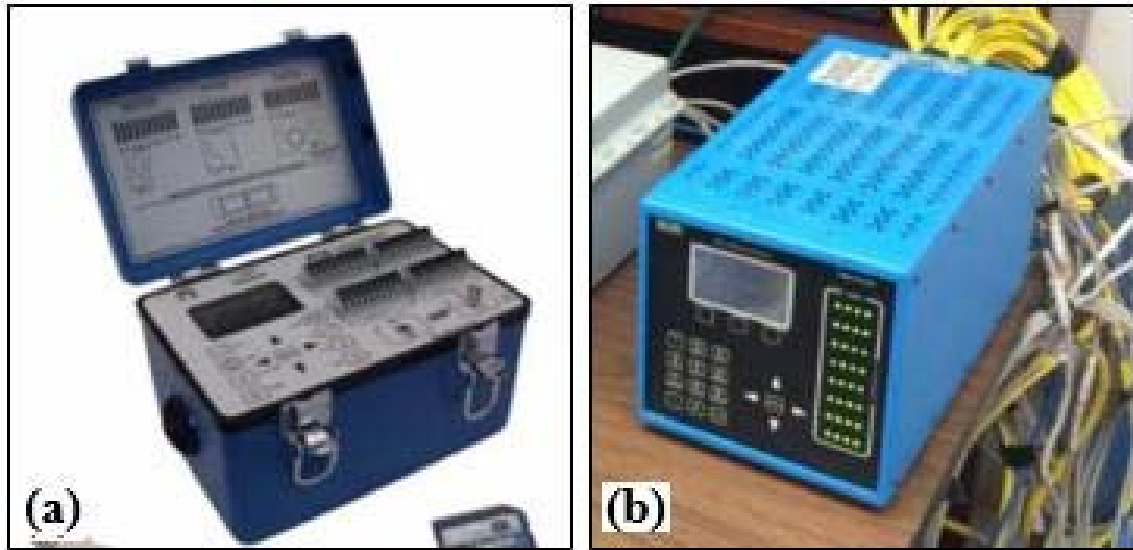
**Figure 3.21 (a) P3 data logger for Test 1, (b) System 7000 data logger for Test 2**

- The data loggers for displacement sensors in Test 1 employed a four-channel P3 model from Vishay™ from the two sensors used for the test with the help of a software specific for this data logger. Figure 3.21 illustrates the P3 data logger.
- A Vishay™ System 7000 32-channel scanner was used to collect and record data from displacement sensors and strain gauges in Test 2. The scanner connects to a desktop computer for data logging. Strain Smart™ software was used to collect and report the data recorded by the scanner. Figure 3.21 presents the scanner used in the Test 2. The details and specifications for the sensor are presented in Appendix B.

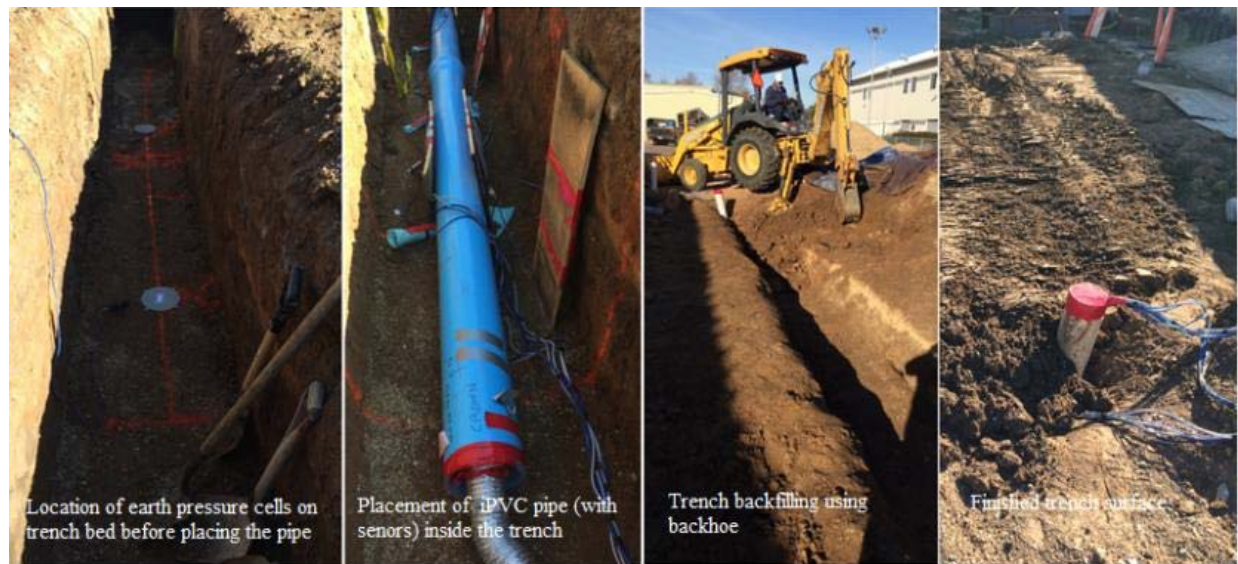
**Figure 3.26 Pipe and sensor installation (Test 2)**

UTA's contractor prepared a trench bottom four inches deep using crushed stone before round two of the bedding test. The round two installation of iPVC pipe was carried out on February 12 and 13, 2016. Figure 3.26 shows the trench at various stages of installation work. Prior to installation, the trench was marked for locations of pressure cells around the pipe. The pressure cells were protected with a thermo-ply sheet to avoid any damage as well as it helps in locating the pressure cells after completion of the testing. The backfilled soil was compacted to a reported 85% - 95% compaction level around the pipe for a depth of two-feet from the bottom of the trench.

The remaining two feet of trench to the surface was backfilled with the lean clay. Extra soil and gravel was added on the surface of the trench after backfilling to stabilize the trench for truck traffic and added more load on the pipe.

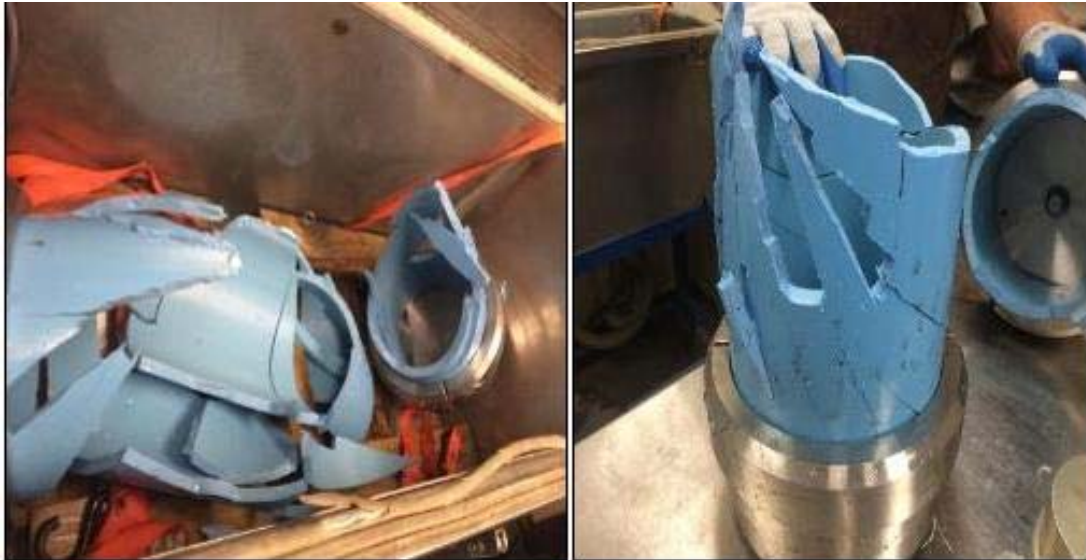
**Figure 4.1 Hydrostatic burst test failures (catastrophic) at UTA**

All the samples tested at the UTA experienced catastrophic failure of iPVC pipe. Figure 4.1 captures the typical catastrophic failure observed during testing of iPVC pipe at UTA. The Microbac lab reported ductile and catastrophic modes of failures during the iPVC pipe testing. A catastrophic failure in which the pipe shattered into pieces implying some response to pipe brittleness and a ductile failure where the pipe responds more elastically and physically changes shape before ultimately splitting to a far less extent. (Failure caused by pressure loss, ballooning of pipe and pin hole leak observed in pipe samples.) Figure 4.2 illustrates both the ductile failure and catastrophic failures observed at Microbac. Table 4.1 presents test results, samples 1 through 10 presents the sample tested at the Microbac lab and samples 11 through 14 presents the outcome of burst test at the UTA.

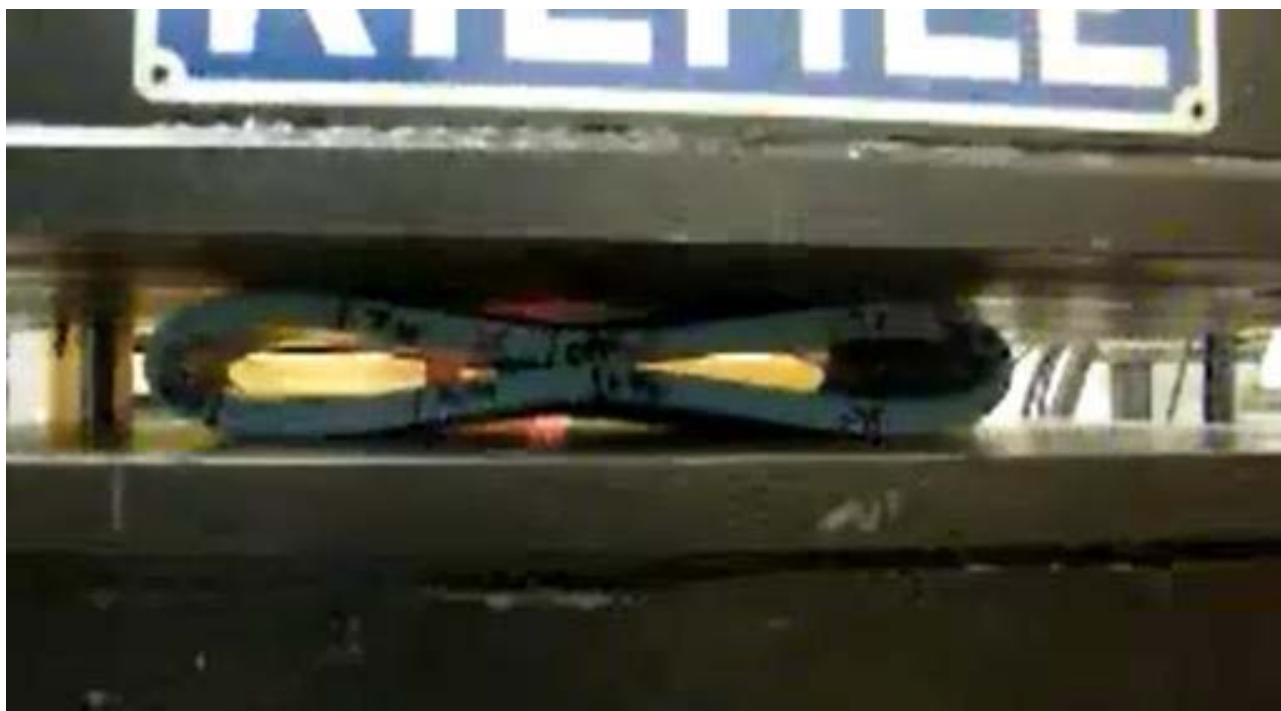
**Figure 4.5 Full deflection of iPVC pipe between plates**

The stiffness test was conducted at the Microbac lab facility to determine the potential for deflection and note the general behavior of the pipe under vertical load. The stiffness test results presented in Table 4.3 were useful for the iPVC pilot installation at the Missouri American Water. The test studied the behavior of pipe at 5% decrements in the mean diameter (D) from 100% of the pipe before load applications to 60% D. At 60%, the experiment was stopped and evaluated for any visual cracks or fracture and none were identified. The experiment continued until the pipe inner walls from the top met the pipe at the bottom (see Figure 4.5). The pipe deformation went beyond a reduction to 20% D without fracture, cracks, or failure. The average pressure recorded beyond 20% D deflection was about 7,500 psi and the average maximum load was about 10,500 psi. Figure 4.6 shows the typical load as a function of the reduction in the mean diameter and Figure 4.7 shows the load as a function of percentage D. For the first 5 inches of reduction, the pipe required a decreasing increment in load to reduce each inch. This trend was reversed in the last two inches of reduction until the limit of reduction was reached when the top and bottom of the pipe were touching and offered additional support. The performance of the all samples tested was consistent as suggested by Figure 4.7.

Microbac tested ten samples reduced in diameter by 5% that supported an average 426 psi. This exceeds the minimum AWWA requirements of 364 psi at 95% diameter (AWWA 2002) by 17%. Stiffness test results are presented in Table 4.5. Figure 4.5 illustrates the load versus deflection of all the pipe samples.

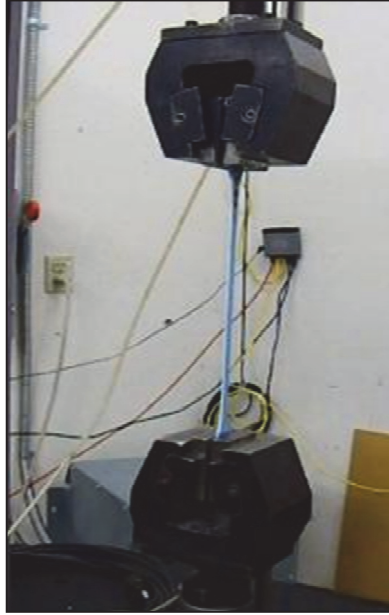
**Figure 4.8 Type I tensile testing at Microbac lab**

Both Microbac and UTA labs conducted tensile tests. The Microbac lab conducted the test with the type I and type III tensile samples and UTA conducted test with the type III samples. The initial tensile test conducted by UTA used full walled samples (coincides the wall thickness of DR 18 PVC pipe = 0.5 inches). To validate the UTA results, 10 type III “dogbone” samples were provided to Microbac. After receiving the tensile test samples, Microbac lab recommended that the tensile test specimen for ASTM 1784 cell class 12454 PVC compound must be prepared per type I (thinner wall) and not type III (thicker wall). The research team decided to pursue testing both the specimens to understand the anomalies in the material configuration. Figure 4.8 presents the tensile test in action at the Microbac Lab and Tables 4.4 and 4.5 present the results of tensile test at the Microbac and UTA (see Table 4.4 for A1-A10 and Table 4.5 for DG through DU).

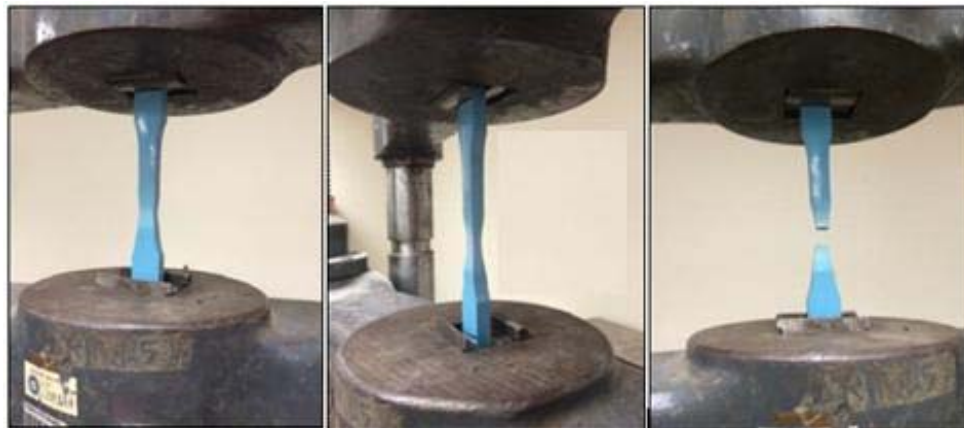
Figure 4.11 Type III tensile testing at UTA

Microbac performed tensile tests ten Type III samples (full-wall) per ASTM D638-14 (first ten values Table 4.5, DB through DN) and UTA labs performed tensile tests on six specimens (last six values Table 4.5 DG through DU). Figure 4.9 presents the tensile test specimen fracture at the UTA. The average tensile strength reported for these test samples was 7,920 psi with modulus of elasticity of 395,000 psi. UTA did not report a modulus of elasticity throughout the tensile test experiment. UTA lacked the proper extensometer component in their tensile test apparatus that is attached to the specimen sample. Microbac explained the lower modulus results of the iPVC pipe was due to the selection of the Type III samples used in the tensile testing. For PVC pipe extruded from ASTM D1784 (ASTM 2011a), Cell Class 12454B PVC compound, the tensile sample is recommended to be prepared per Type I dimensions specified under ASTM D638. The available results are summarized in Table 4.5. Figure 4.12 and Figure 4.13 present graphical summary of tensile strength and modulus of elasticity values of the Type III iPVC pipe samples.

For the type I test, the average tensile strength observed was 7,930 psi with a modulus of elasticity of 461,000 psi. Table 4.4 summarizes the test results from the Microbac for type I pipe samples. Figure 4.9 and Figure 4.10 present a graphical summary of tensile strength and modulus of elasticity values of the type I iPVC pipe samples. Figure 4.11 shows how the samples performed as they were tested.

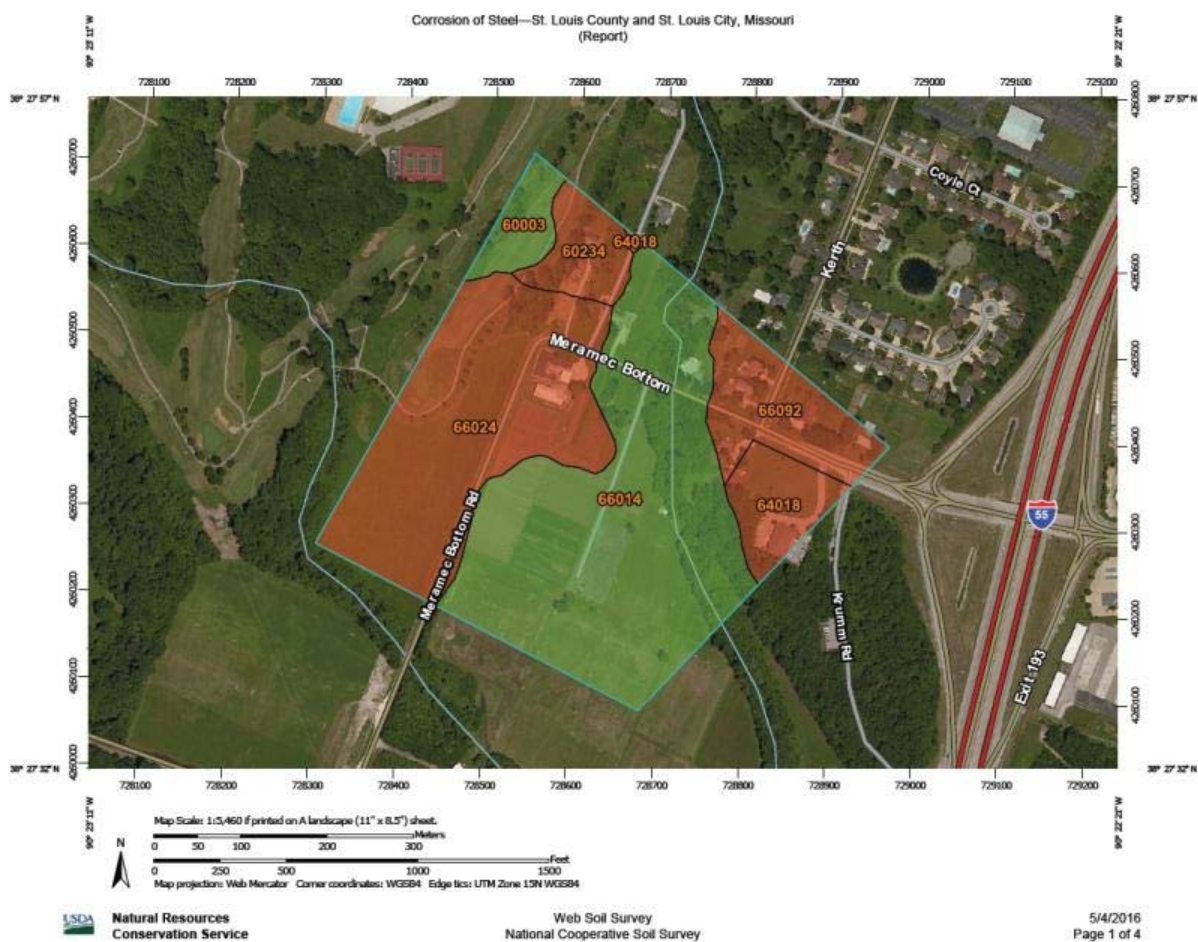
**Figure 5.2 USDA web soil survey at the pilot installation**

To verify the corrosive index of soil near the pilot installation, American Water checked the United States Department of Agriculture (USDA) web soil survey (Figure 5.2). The area of web survey for corrosivity is represented under the polygon (labelled area of interest (AOI)). The AOI includes the area of the iPVC installation. The pipeline was constructed in the areas designated 66024 and 66014 per Figure 5.3. From the web survey confirmed the area as silty loam. The corrosion rating for the area highlighted 66024 is high and the area highlighted 66014 is low. The web survey also confirmed the highlighted area within the flood zone. There were some delays for securing a regulatory permit to install pipe in a flood zone.

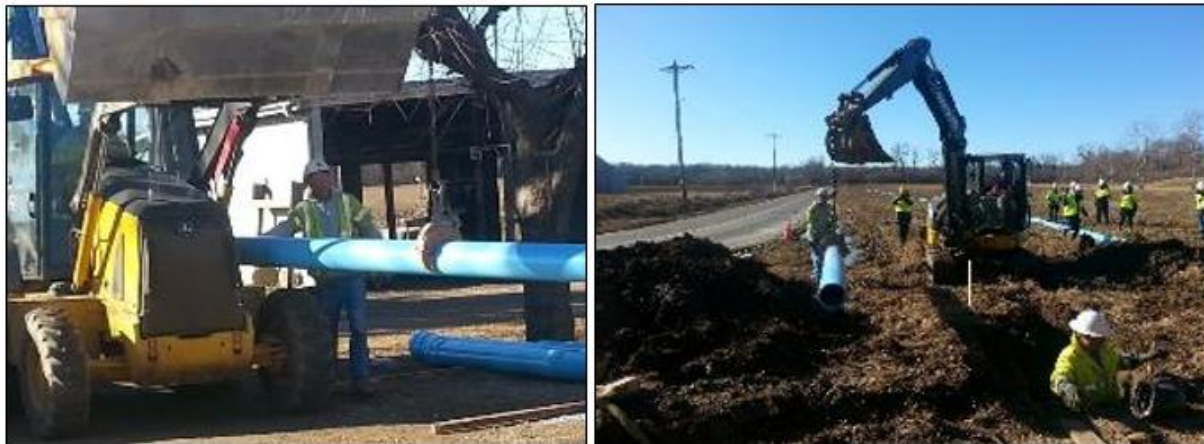
**Figure 5.4 iPVC delivered to the trench**

The installation process included handling, cutting, trimming, tapping, and connecting to various fittings and other pipe materials (Figure 5.4). The crew completed the installation in a few

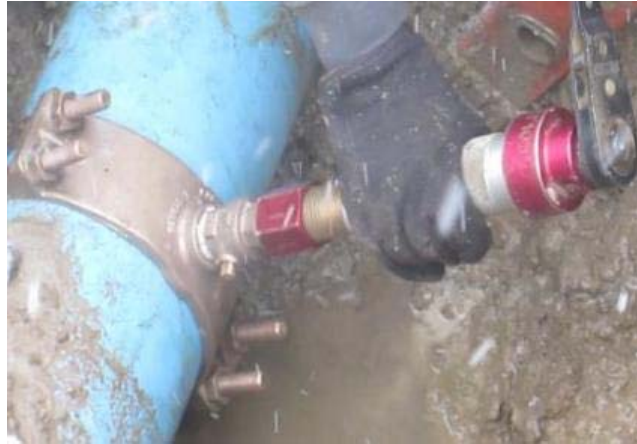
**Figure 5.5 Tapping the iPVC pipe per AWWA guidelines**

Five customer services were relocated to the iPVC main. The service connections were executed by hot tapping the pipe using appropriate tapping and saddle materials. MOAW confirmed that the installation of the iPVC pipe was no different from the conventional PVC pipe installation (Figure 5.5).

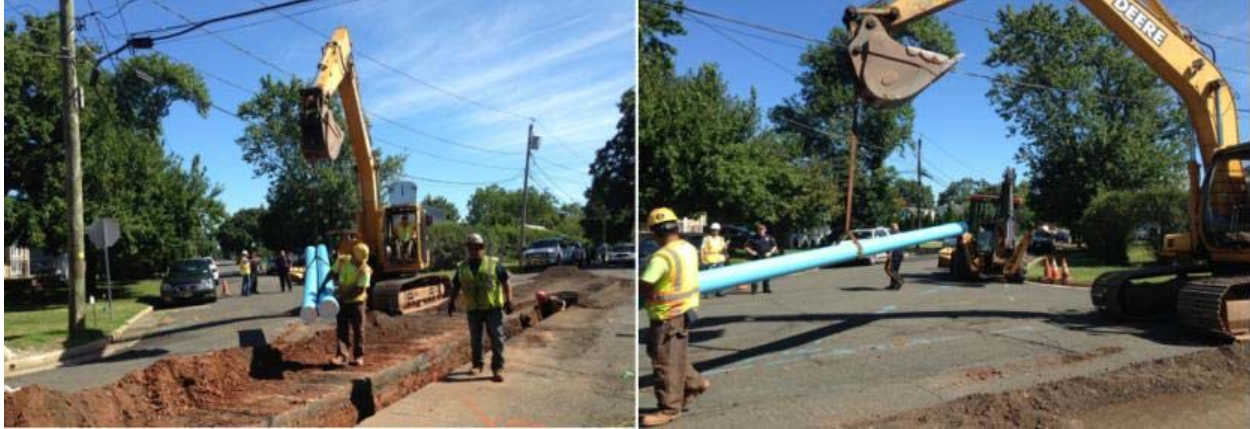
**Figure 5.8 Contractor installing new iPVC pipe at Manville, NJ**

The New Jersey American contractor followed open cut procedures to install the iPVC pipe in compliance with AWWA C605, PVC installation procedure. The installation began during the first week of September 2016 and completed in October 2016. The installation processes included handling, cutting, trimming, numerous tappings, valve connection and connecting to the existing system. The contractor flushed, pressure tested (150 psi), and disinfected the iPVC pipe per AWWA C605. Figure 5.8 shows the installation of iPVC pipe at Gary Street, Manville, NJ.

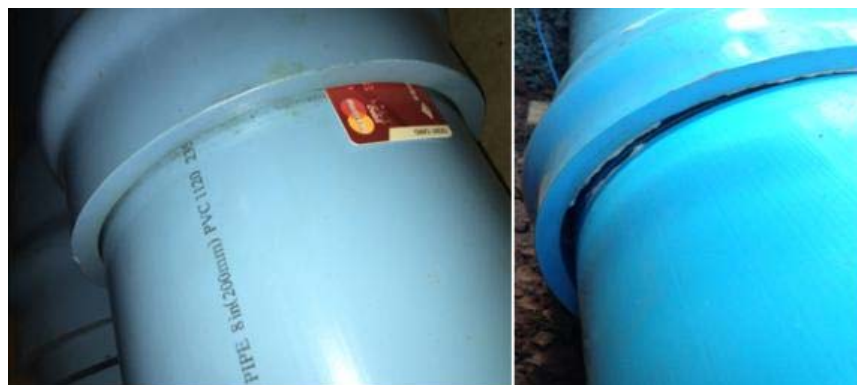
**Figure 5.9 Separation at the joint from the new Trelleborg gasket**

The Trelleborg Company manufactures the gaskets in Germany that are used with European PVC-O pipe. PPII conducted successful leak and burst tests on their iPVC pipes with the Trelleborg gaskets before changing to this more flexible design but did not realize there would be installer's concern about the flexibility provided by the gaskets.

The flexibility of gaskets has suggested additional opportunity for the iPVC that are currently under study. PPII had previously advised that they do not allow deflection at pipe joints but the use of the gaskets and some testing by PPII at their Korean facility and studies at Cornell University for earthquake resistance may lead to flexibility for deflection in the near future. The new iPVC pipe installed with minimum deflection passed the pressure testing without any leaks. Figures 5.9 and 5.10 provide the information on the new iPVC pipe gasket. A change in the criteria for the iPVC pipe relevant to deflection is under discussion but not formerly changed at this time.

There was a work stoppage when the gaskets employed were called into question but essentially the installation took the same time with similar costs as conventional PVC. The gaskets and their flexibility to cause some minor concern as a conscientious effort was made to minimize deflection at the joints throughout the installation though this may not have been necessary.

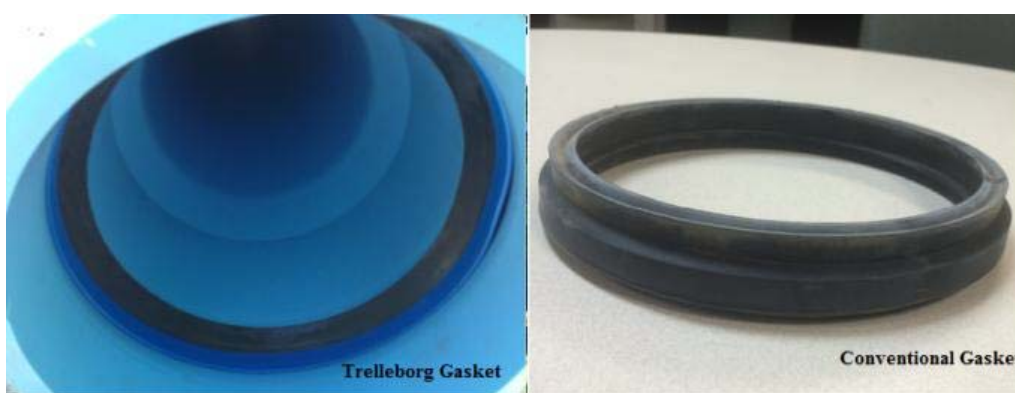
**Figure 5.10 Trelleborg gasket versus conventional PVC gasket**

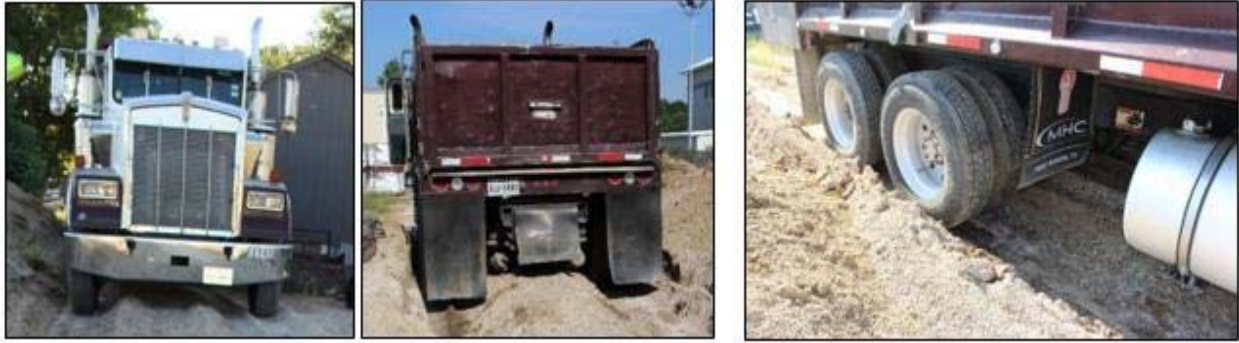
**Figure 5.16 Twenty-ton truck providing live load, June 30, 2015**

The test one truckload was applied on June 30, 2016. Figure 5.16 shows photographs of the live load testing. Tables 5.5, 5.6, and 5.7 present the deflection, strain, and earth pressure readings for 1 hour before, 4 hours during, 1 hour after, 1 week after, and 2 weeks after applying round 1 truck load. Figures 5.17-5.21 graphically display the vertical deflection, horizontal deflection, strain at joint, strain at end of pipe and earth pressure readings, respectively. The vertical deflection readings displayed a maximum rise of 0.944 mm and 0.931 mm at the joint and end of the pipe respectively. The horizontal deflection readings displayed a maximum rise of 0.579 mm and 0.711 mm at the joint and end of the pipe respectively. As the load was removed, there was reduction in the deflection values recorded after a couple of weeks but the pipe failed to reach to the original deflection values observed under only the earth load. The change may have been due to a change in the earth loading as gravel was added to stabilize the truck path over the pipe.

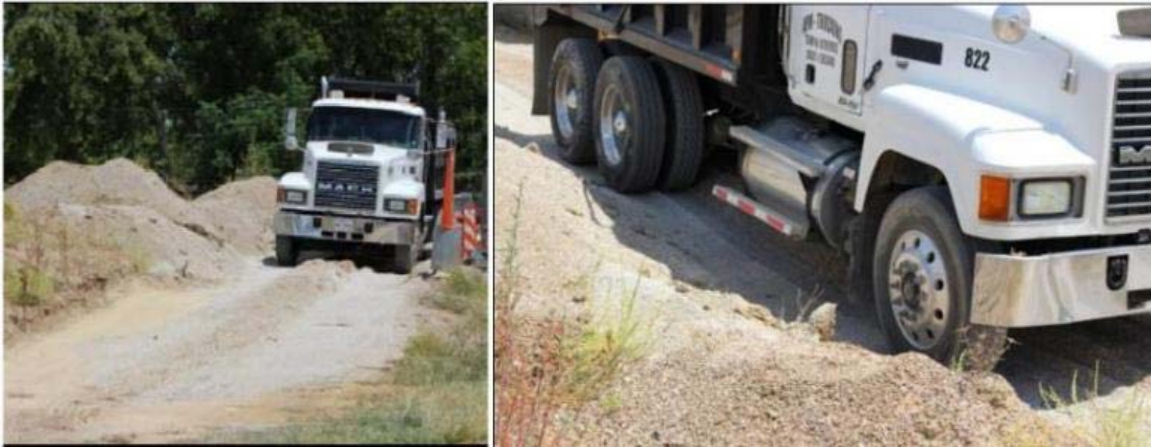
**Figure 5.22 Twenty-ton truck creates live load on August 8**

The second round truckload was applied on August 8, 2016. Figure 5.22 shows photographs of the round two live load testing. Tables 5.8, 5.9, and 5.10 present the deflection, strain, and earth pressure readings for one hour before, nine hours during, one hour after, one week after, and two weeks after applying round two truck loads. Three of the earth pressure cells stopped functioning prior to the test and hence there are no readings for these three pressure cells in Table 5.8. Figures 5.23 – 5.27 graphically illustrate the vertical deflection, horizontal deflection, strain at joint, strain at end of pipe and earth pressure readings, respectively. The vertical deflection readings displayed a maximum rise of 0.808 mm and 1.23 mm at the joint and end of the pipe respectively. The horizontal deflection readings displayed a maximum rise of 0.449 mm and 0.714 mm at the joint and end of the pipe respectively.

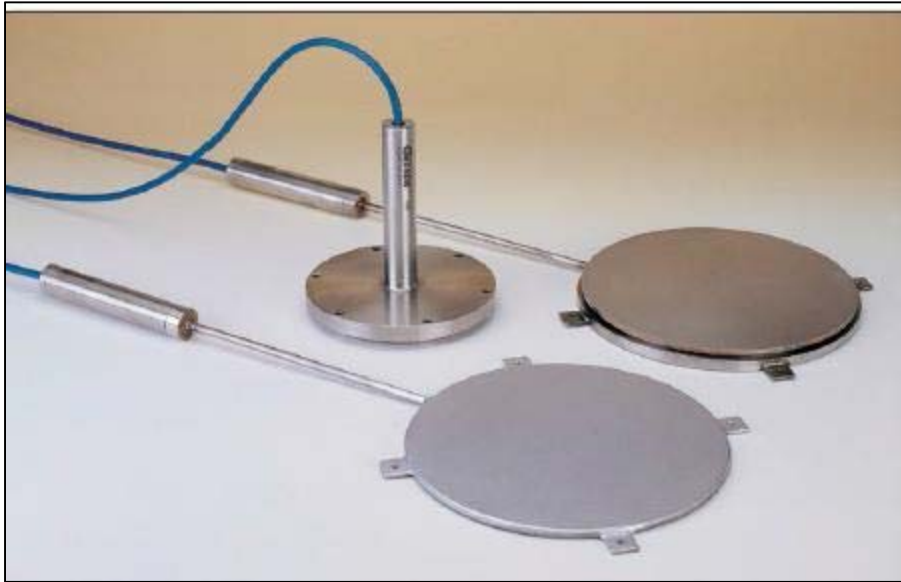
**Figure B.1 Geokon earth pressure cell**

The figures below present the instrumentation used during the bedding test.

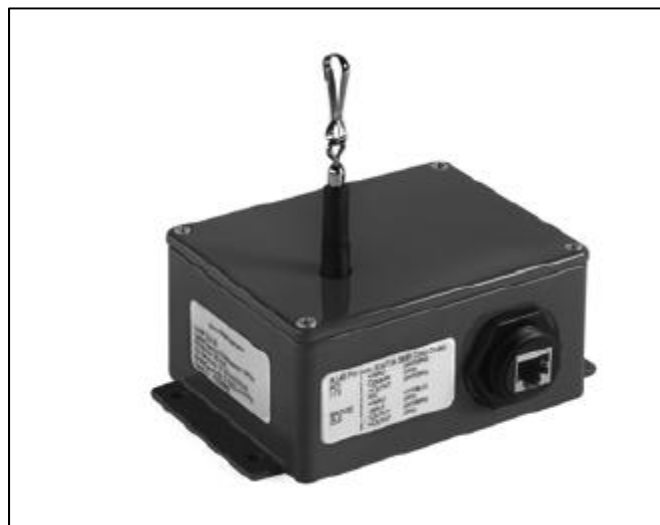
**Figure B.3 Vishay deflectometer (used as displacemnet sensors)**
